**Continental Business Center (aka Bridgeport Industrial Park) Fire
CERCLA Emergency Response
Bridgeport, Montgomery County, PA**

**RECORD OF USEPA ACTIVITIES
"OSC RECORD"**

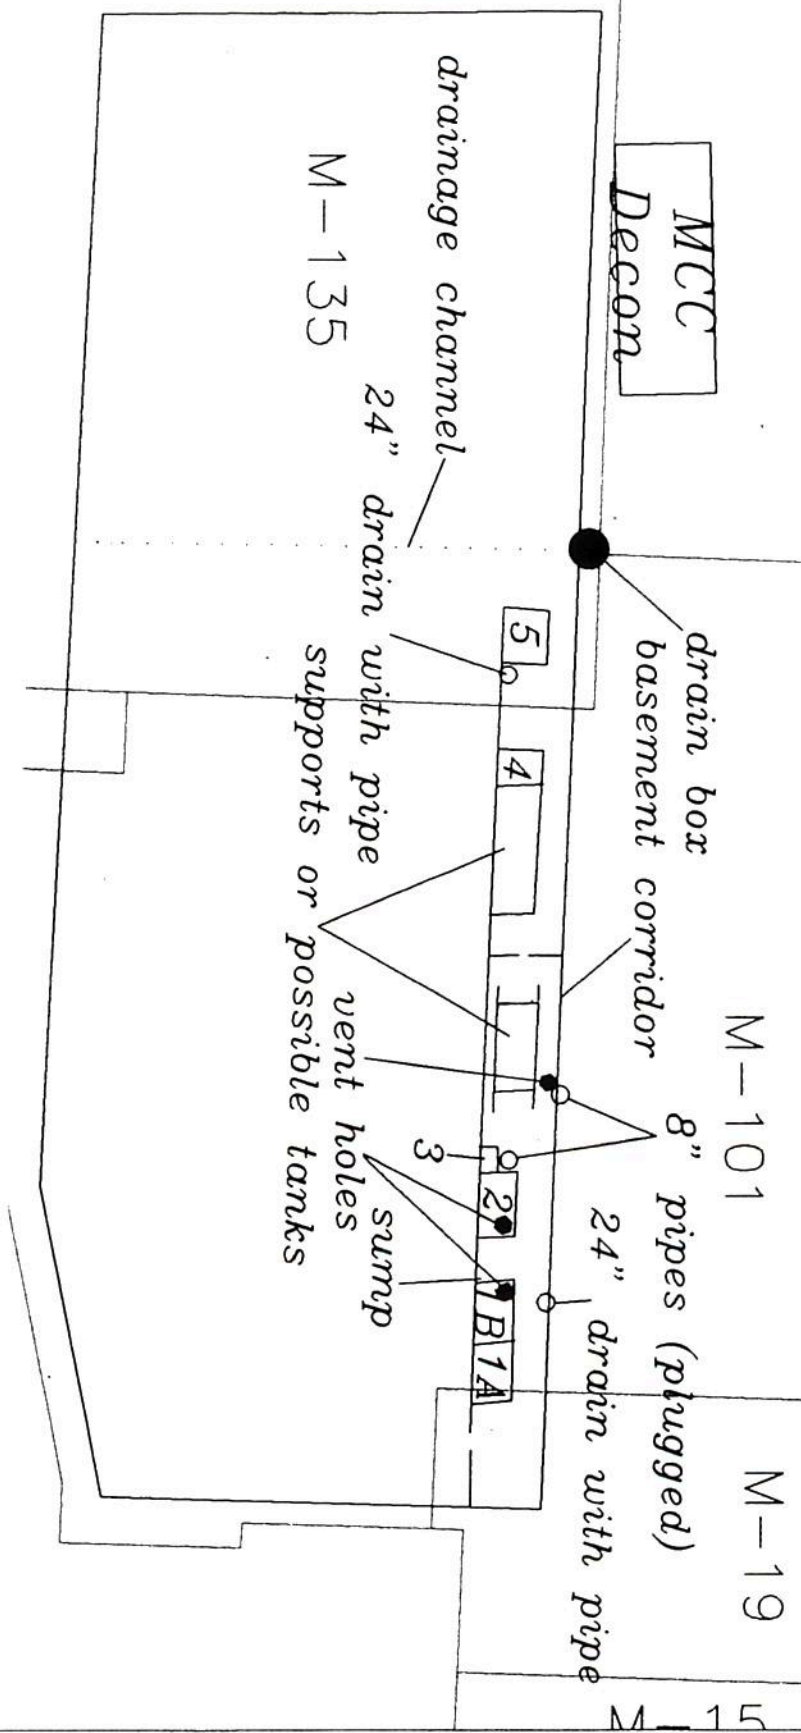
| | FIGURE 1 |

* THIS MAP PREPARED BY USCG-AST
AFTER SEVERAL ENTRIES INTO BASEMENT
AREA MAP DEFECTS AN EAST-WEST
TRENDING CORRIDOR (SEE GRID #14
ON CONTINENTAL D. AMONG PLOT)

- TANK SUMMARY
- 1A - 1/4 full
 - 1B - full
 - 2 - full
 - 3 - empty
 - 4 - empty
 - 5 - empty
